National Dam Inspection Program.
Duck Harbor Pond Dam (NDI ID Number
PA-00144, DER ID Number 64-54), Dela-
ware River Basin, Little Equinunk Creek,
Wayne County, Pennsylvania. Phase I
Inspection Report,

DUCK HARBOR POND DAM

NDI ID No. PA-00144

PHASE I INSPECTION REPORT
NATIONAL DAM INSPECTION PROGRAM

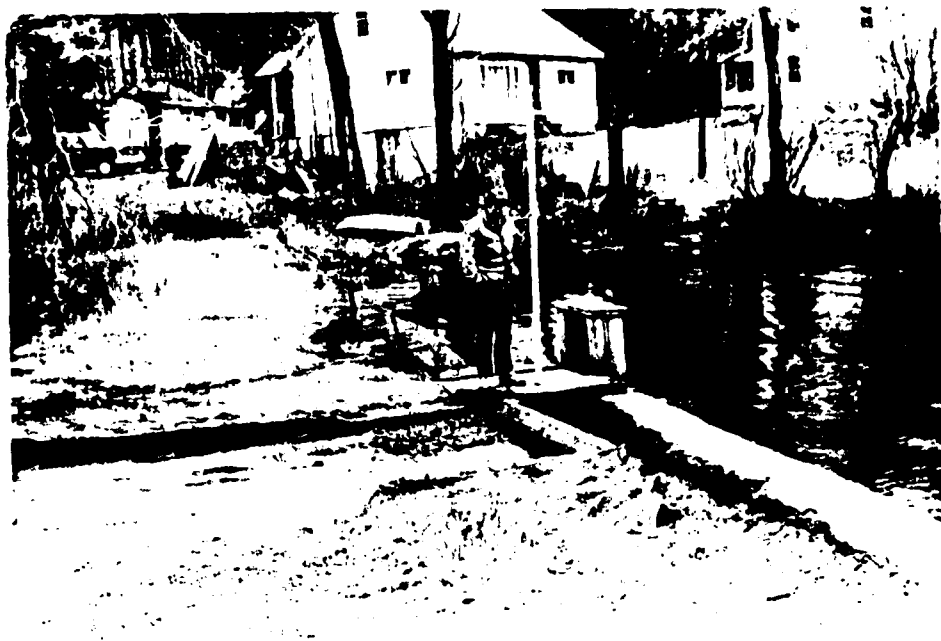
C. Top of Dam

(1) As part of the regular maintenance program, remove trees growing along the toe of the dam and replace the missing stones at the top of the dam.
